Custom Solutions for High Arc Flash Incident Energy and Interlocked Electrical Enclosures

By Mark Bowling, Level II Thermographer, IRISS Inc. & Rick Miner, Level III Thermographer, Thermal Techniques

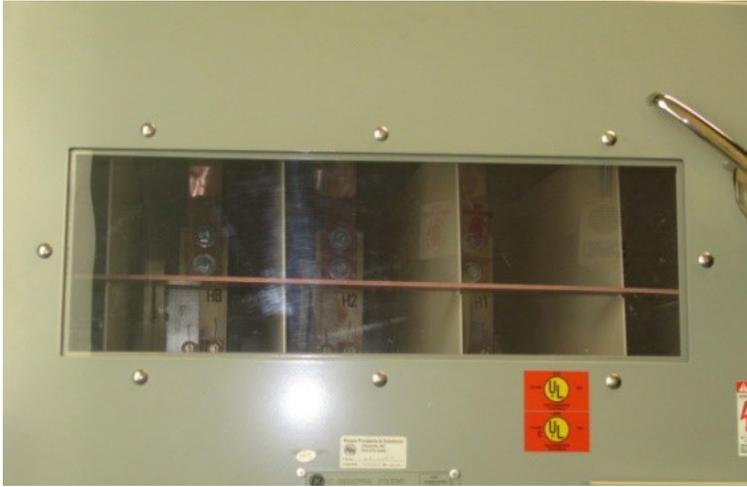
The existing switches had a large Plexiglass viewport (See Figure 1) in the upper portion of the cabinet and arc flash barriers between the fuses at the bottom of the cabinet. The Plexiglass window provided a direct line of site of incoming lugs, disconnect switch, and the top of the fuses.

Figure 1 existing plexiglass window

Plexiglass material does not allow infrared radiation to pass through it and be seen with a thermal imaging camera. The Plexiglass window was held in place by eight (8) easily removable mounting bolts. Measurements of the opening and bolt hole locations were made. This data was provided to IRISS who made a template of the opening. The template was made and sent to the site. The opening and bolt hole locations were fine-tuned so that an exact Flex IR custom replacement could be installed using the same mounting as the original Plexiglass (See Figure 2).

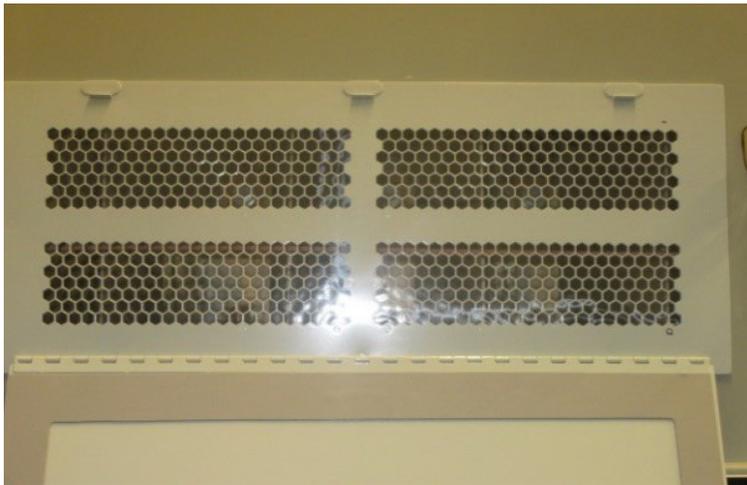
Figure 2 Flex IR custom designed IRISS 24" high x 8" wide polymer infrared window replacement

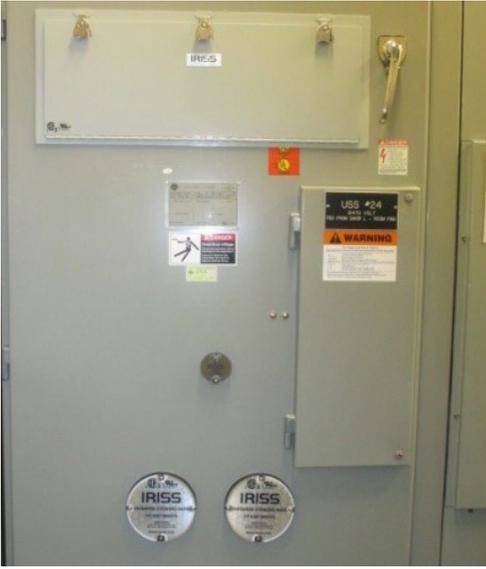
Figure 3

- High voltage switch gear was de-energized IR windows were installed and returned to service without incident
- All electrical components can now be viewed during the scheduled annual infrared testing, while equipment is energized.
- The switches can be inspected at any time in compliance of NFPA 70E and safety standards.
- Installation was accomplished in 8 hours, well within the allocated maintenance time.
- The finished product is professional looking and well-engineered (Figure 3)

By installing a polymer window to replace the Plexiglas window and two 4" round window for the fuses all components within the cabinets could be inspected with a thermal camera. The installation of an ultrasound port enabled the site to comply with the request of the insurance carrier.

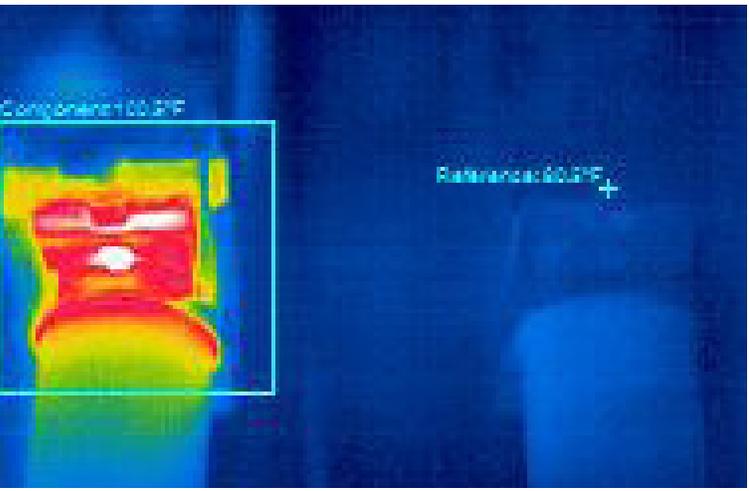
Figure 4

Shortly after completion of the installation a complete infrared inspection was performed. For the first time since the building was placed in service, the medium voltage interlocked cabinets could accurately be inspected. One of the fuse clip holders was identified as operating at an elevated temperature with a high resistance connection, and repairs were subsequently scheduled. (See Figure 4)
