# Case Study

Custom Solutions for High Arc Flash Incident Energy and Interlocked Electrical Enclosures

By Mark Bowling, Level II Thermographer, IRISS Inc. & Rick Miner, Level III Thermographer, Thermal Techniques

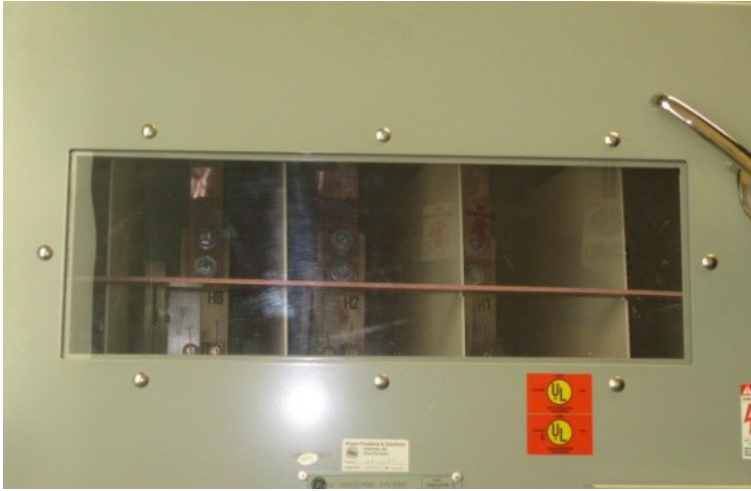
The existing switches had a large Plexiglass viewport (See Figure 1) in the upper portion of the cabinet and arc flash barriers between the fuses at the bottom of the cabinet. The Plexiglass window provided a direct line of site of incoming lugs, disconnect switch, and the top of the fuses.

Figure 1 existing plexiglass window

Plexiglass material does not allow infrared radiation to pass through it and be seen with a thermal imaging camera. The Plexiglass window was held in place by eight (8) easily removable mounting bolts. Measurements of the opening and bolt hole locations were made. This data was provided to IRISS who made a template of the opening. The template was made and sent to the site. The opening and bolt hole locations were fine-tuned so that an exact Flex IR custom replacement could be installed using the same mounting as the original Plexiglass (See Figure 2).

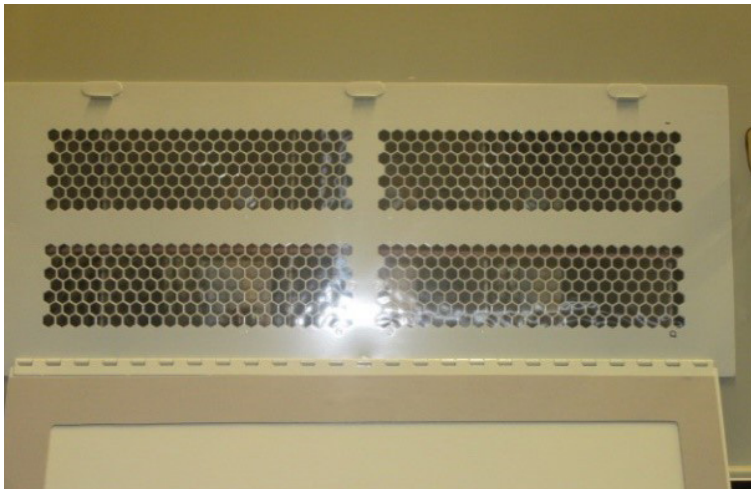
Figure 2 Flex IR custom designed IRISS 24" high x 8" wide polymer infrared window replacement

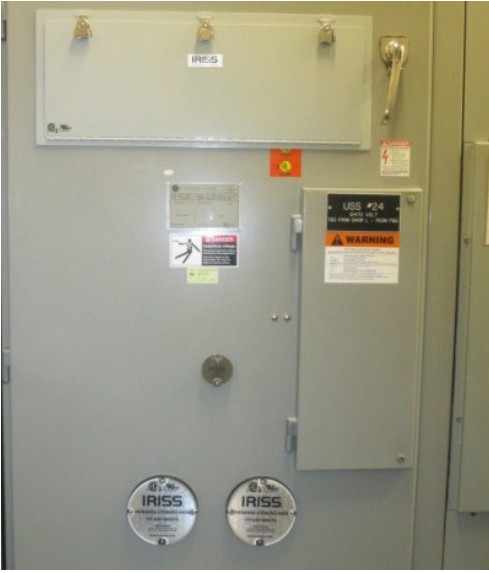
Figure 3

- High voltage switch gear was de-energized IR windows were installed and returned to service without incident
- All electrical components can now be viewed during the scheduled annual infrared testing, while equipment is energized.
- The switches can be inspected at any time in compliance of NFPA 70E and safety standards.
- Installation was accomplished in 8 hours, well within the allocated maintenance time.
- The finish product is professional looking and well-engineered (Figure 3)

By installing a polymer window to replace the Plexiglas window and two 4" round window for the fuses all components within the cabinets could be inspected with a thermal camera. The installation of an ultrasound port enabled the site to comply with the request of the insurance carrier.

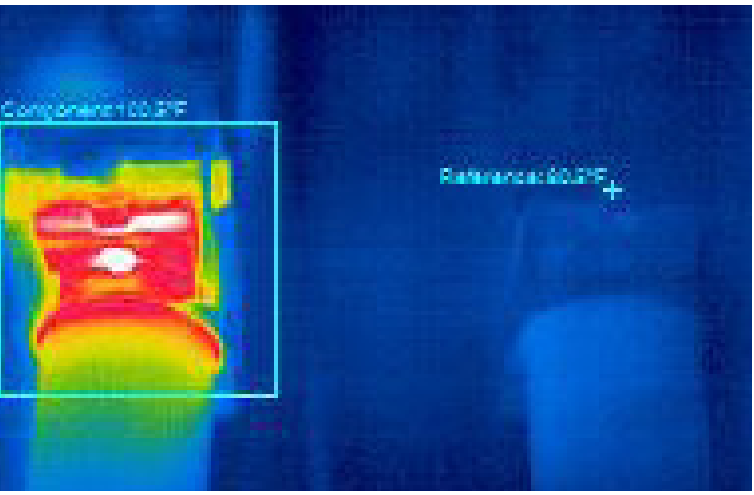
Figure 4

Shortly after completion of the installation a complete infrared inspection was performed. For the first time since the building was placed in service, the medium voltage interlocked cabinets could accurately be inspected. One of the fuse clip holders was identified as operating at an elevated temperature with a high resistance connection, and repairs were subsequently scheduled. (See Figure 4)
