# Case Study

A Multi-Tenant 1,000,000 Square Foot Commercial Office Building in Jersey City, N.J. Part 3

By Martin Robinson, CMRP Level III Thermographer President, IRISS Inc.

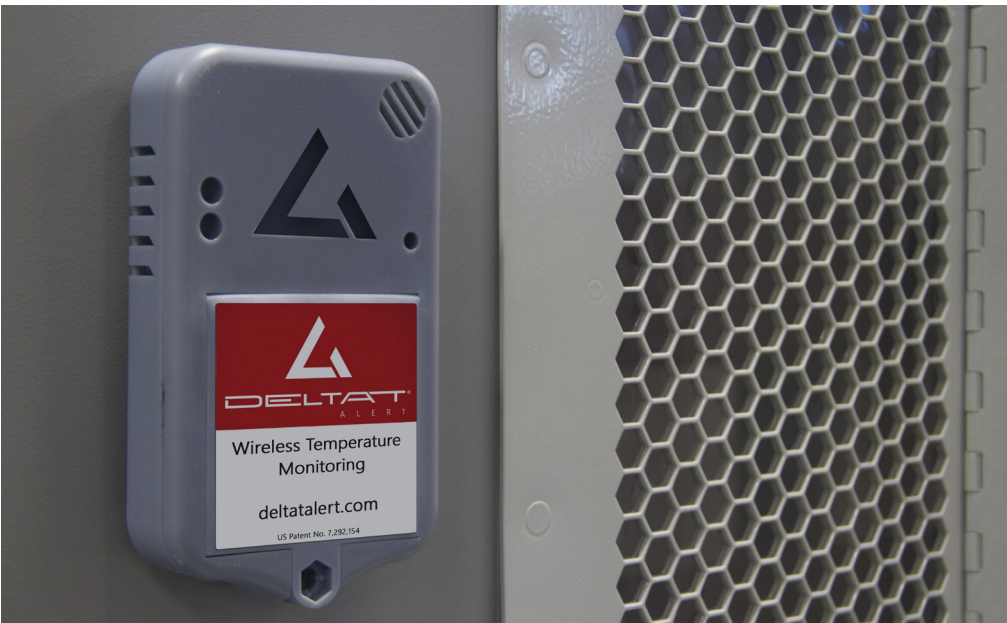
Location	MCC-Panel	Equipment ID	Equipment Type	Enclosure Temp	Delta T	Reported	Status
1st Floor E.C.	N/A	D5-1A	Fused Disconnect	80.2	3.4	05/05 10:08	OK
1st Floor E.C.	N/A	D5-1C	Disconnect	73.29999	0.7	05/05 10:02	OK
1st Floor E.C.	N/A	PP-1A	Power Panel	74.3	2.5	05/05 10:06	OK
1st Floor E.C.	N/A	PP-1A	Power Panel	80.1	0	04/20 07:32	No Response
1st Floor E.C.	N/A	T-EMLTG	TP-158	195.3	8	05/05 10:14	CRITICAL
2nd Floor E.C.	N/A	D5-2A	Fused Disconnect	94.8	7.2	05/05 10:03	OK
2nd Floor E.C.	N/A	D5-2B	Disconnect	73	3.4	05/05 10:10	OK
2nd Floor E.C.	N/A	DP-2A	Distribution Panel	70.9	1.1	05/05 10:16	OK
3rd Floor E.C.	N/A	D5-3A	Disconnect	71.6	1.6	05/05 10:08	OK
3rd Floor E.C.	N/A	D5-3B	Disconnect	73	2.8	05/05 10:13	OK
3rd Floor E.C.	N/A	DP-3A	Distribution Panel	72.89999	2.7	05/05 10:18	Low Battery

Figure 1 Transformer T-EMLTG showing an enclosure temperature of 195.3°F

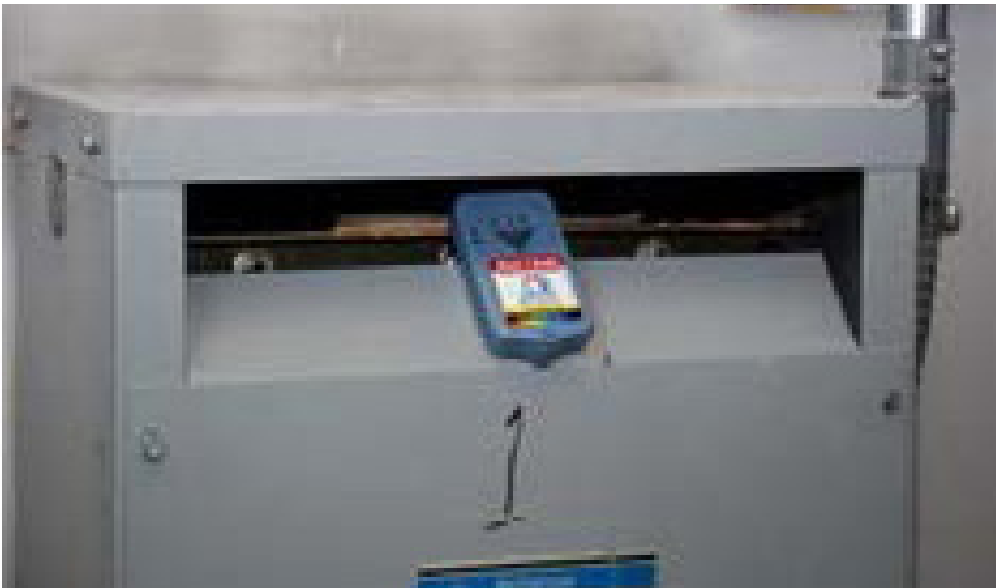
Figure 3 The Delta T Alert was magnetically installed on the vent of this transformer.
